ARTIFICIAL ICING TESTS CH-47C HELICOPTER

Army Aviation Engineering Flight Activity
Edwards Air Force Base, California

August 1974

4. TITLE (and Subtitle) ARTIFICIAL ICING TESTS CH-47C HELICOPTER		5. TYPE OF REPORT & PERIOD COVERED FINAL REPORT 8 April - 2 May 1974
7. AUTHOR(s) MAJ CARL F. MITTAG, CPT MARVIN L. HANKS, CPT JAMES C. O'CONNOR, CPT LOUIS KRONENBERGER JR		6. PERFORMING ORG. REPORT NUMBER USAAEFA PROJECT NO. 73-04-1

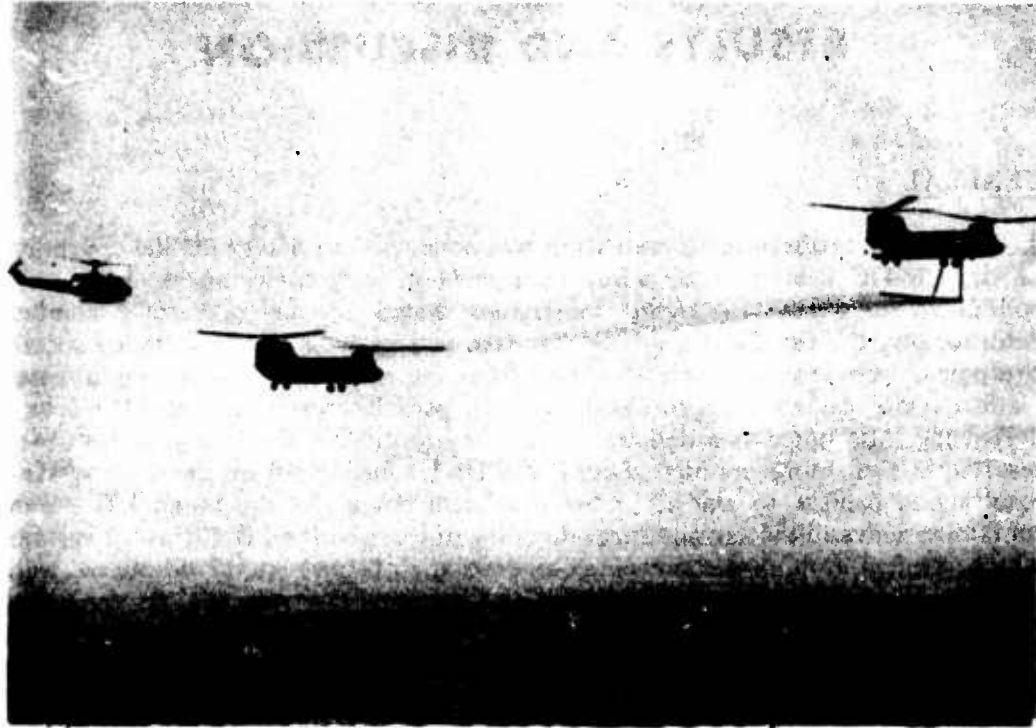
9. Prior to commencing the icing tests, a wake turbulence and helicopter immersion evaluation was conducted with the CH-47C test helicopter behind the CH-47C HISS. Accurate aircraft positioning and stabilized flight conditions could be maintained in the HISS downwash at standoff distances less than 300 feet. At distances greater than approximately 300 feet behind the HISS, the downwash effects of the rotor systems dissipated and disrupted the spray cloud, rendering it unusable for quantitative test purposes. Additionally, stabilized flight conditions could not be maintained in the test vehicle for standoff distances in excess of 300 feet. The most stable flight conditions for the test helicopter in the spray cloud were at a standoff distance of approximately 110 feet. Stabilized flight at this distance could be achieved with minimal cyclic inputs and torque changes of ± 2 percent. The CH-47C helicopter is shown in the spray cloud in photo A.

Photo A. Typical Icing Flight Formation.

10. The usable artificial icing cloud produced by the HISS was approximately 5 feet thick by 75 feet wide by 200 feet long. The cloud width and length permitted positioning of the test helicopter in the cloud to simultaneously ice both the advancing and retreating blades of one rotor system. The HISS spray cloud vertical thickness (5 feet) required separate and individual icing of the forward rotor, the aft rotor, the windshield/chin bubble area, and the lower fuselage area. Fragmented icing of the helicopter does not duplicate a natural icing environment. The level flight, autorotational descent, and vibration data obtained from these artificial icing tests do not accurately quantify the effects of an icing environment affecting the total helicopter. Further tests, utilizing a modified HISS or other device which creates a spray cloud of sufficient size to totally immerse the test helicopter, are recommended to completely evaluate operation of the CH-47C helicopter in an artificial icing environment.

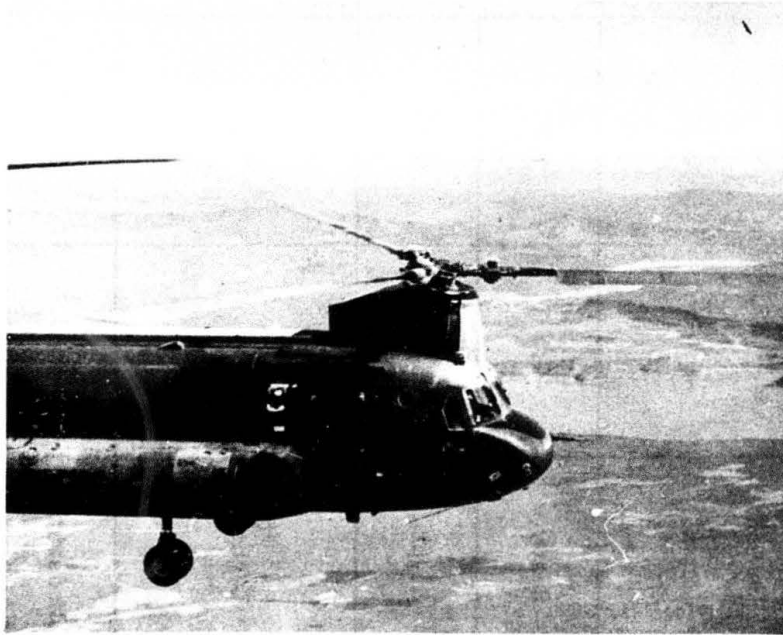
12. Ice thickness observed on the visual ice accretion probe during this evaluation varied from 1/16 inch to 1 inch of glime ice (mixture of clear and rime). Typical ice formations on the forward and aft pylon areas are shown in photos B and C, respectively. The amount and type of rotor blade ice accumulation could not be postflight-documented due to the above-freezing ambient temperatures on the ground. If a quantitative measurement of rotor blade ice accretion is desired in future tests, a method of in-flight measurement must be devised or the ambient temperature must be low enough to permit ground measurement of the ice accumulation. The amount of ice accumulated during each flight was limited by the quantity of water contained in the spray helicopter and the test techniques dictated by the limited spray cloud vertical thickness.

Photo B. Ice Accumulation on the Forward Rotor System and Pylon Area.

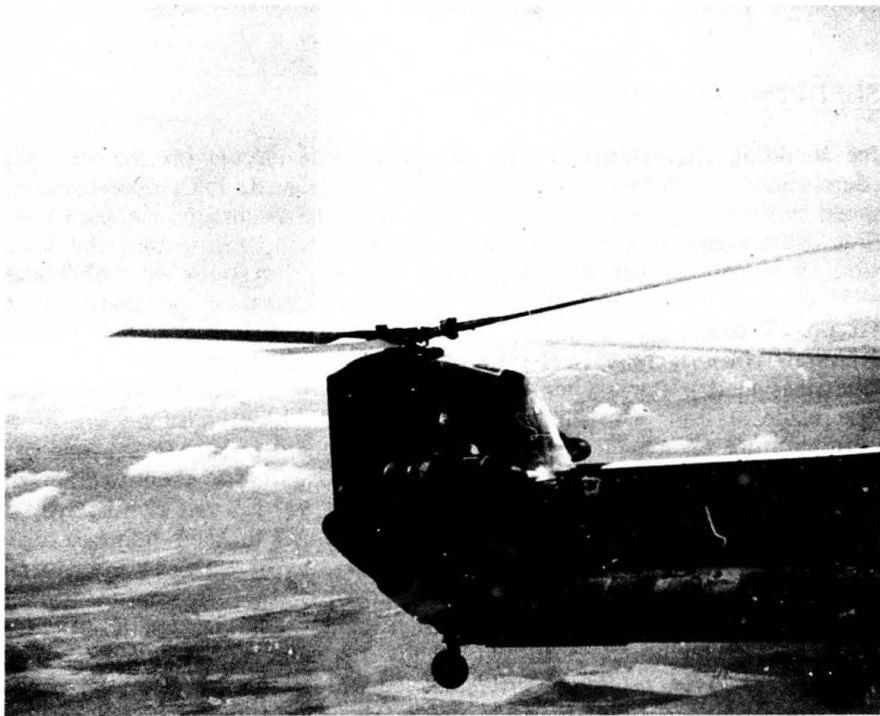
Photo C. Ice Accumulation on the Aft Rotor System and Pylon Area.
